Kansas Department of Health and Environment

Preliminary Assessment 2

IMP Boats Site
(Lanyon #1 and #2)
Iola, KS

Bureau of Environmental Remediation

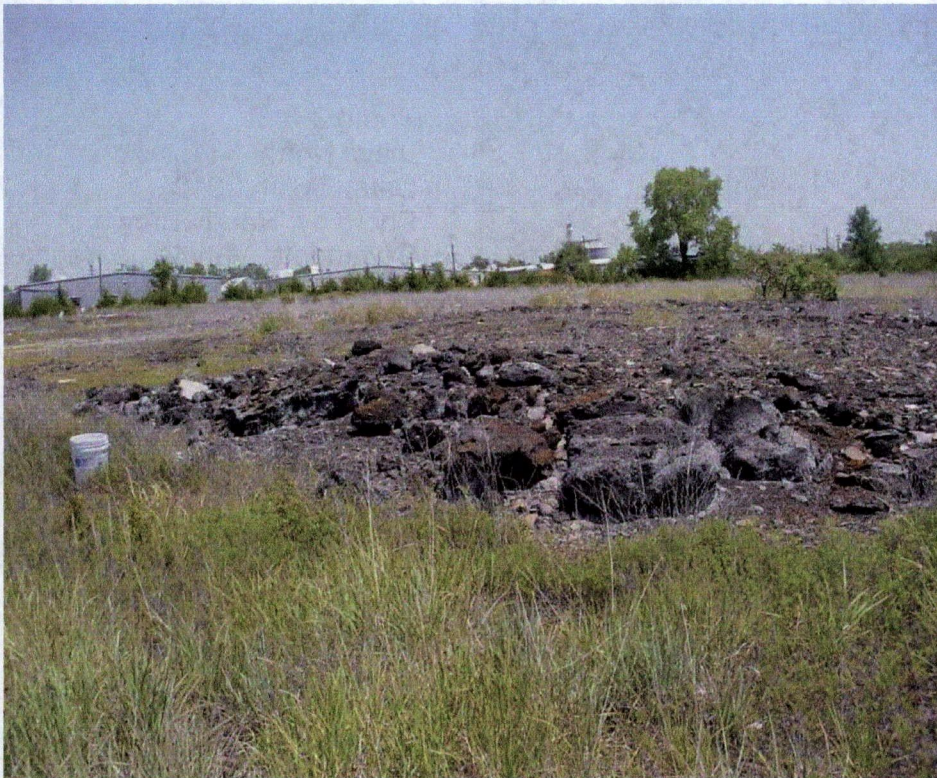
Photo 1

Comments: IMP Boats site.

The area is filled with smelter slag and waste.

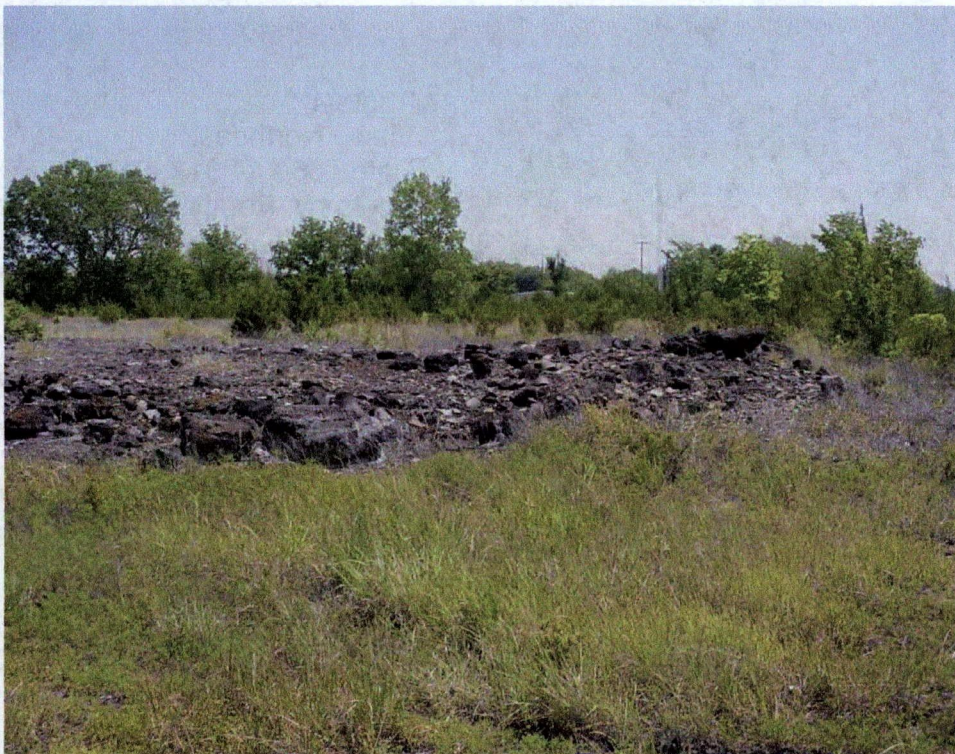
Photo 2

Comments: Photo shows large smelter slag pile near center of the site. GPS coordinate PT-1 was obtained in this area.

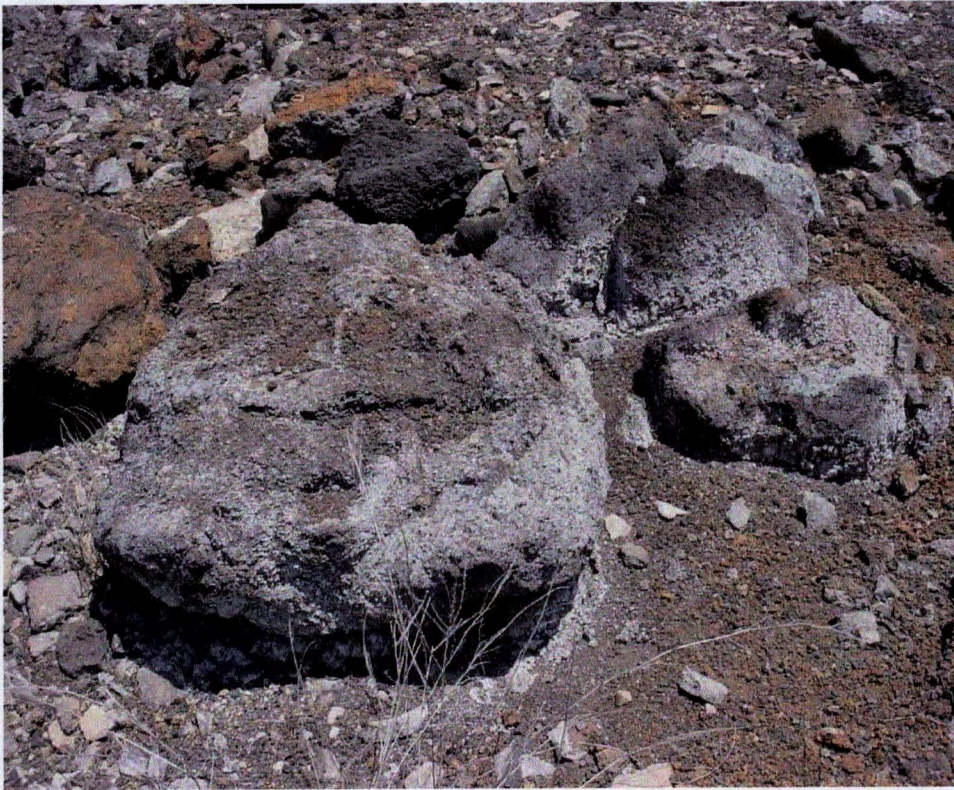
Photo 3
View: North
Date: 06/14/2012
Photo by: Randy Brown
Comments: Very large fragments of smelter waste near center of the site.

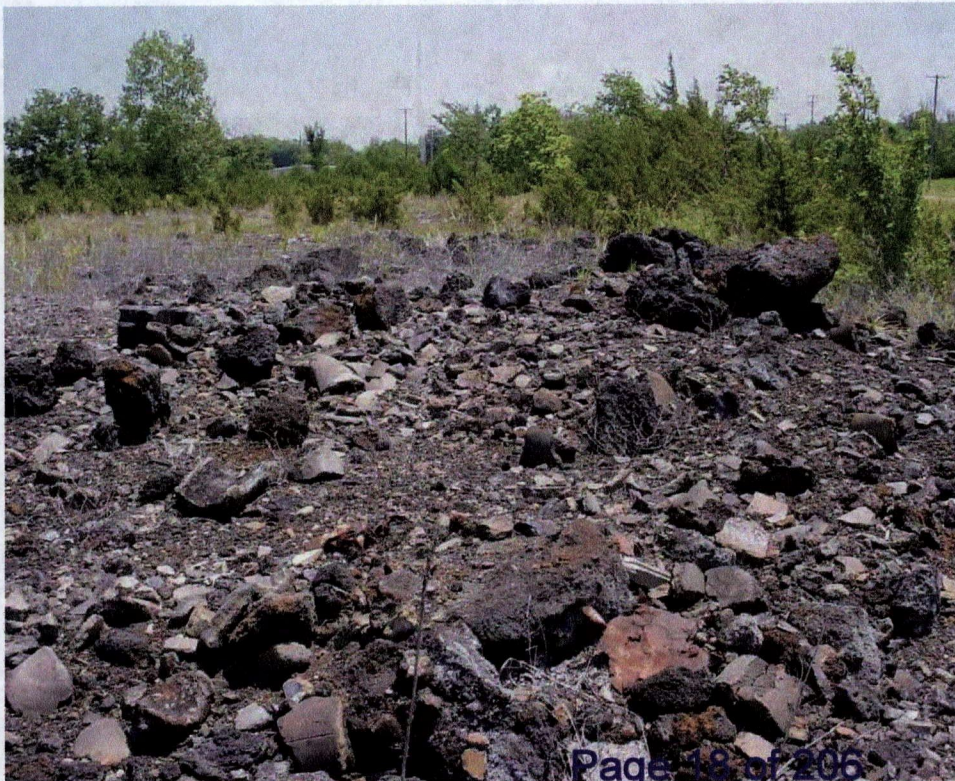
Photo 4
View: Northeast
Date: 06/14/2012
Photo by: Randy Brown
Comments: Photo shows large smelter slag pile near center of the site. Broken retorts, smelter slag and other smelter waste covers the surface throughout this area.

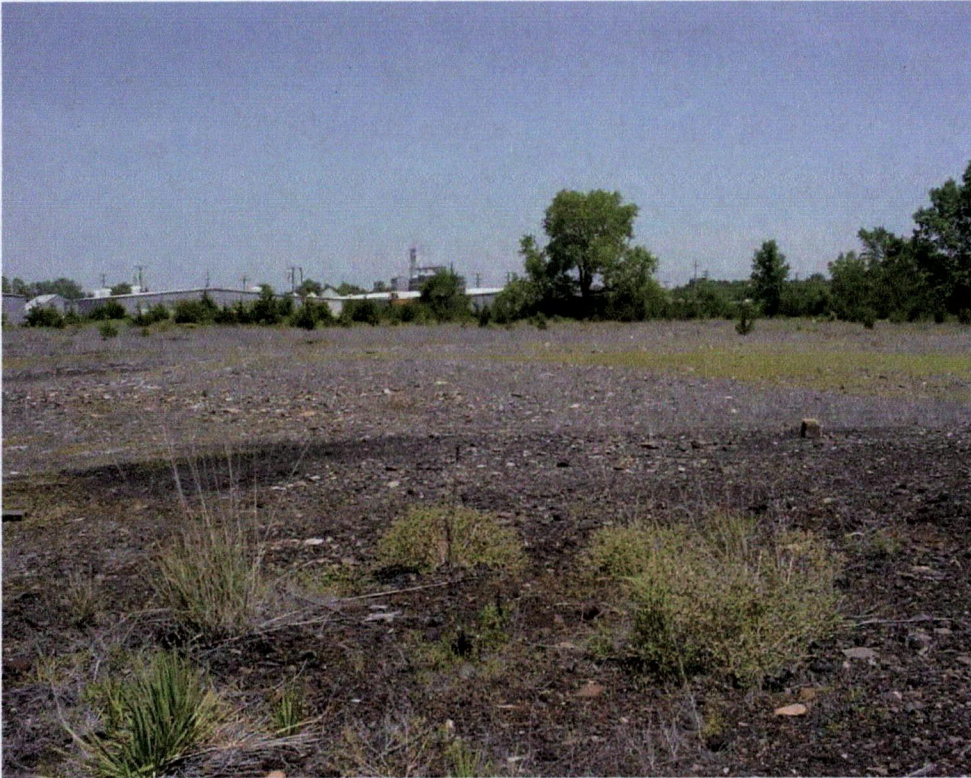
Photo 5
View: North
Date: 06/14/2012
Photo by: Randy Brown
Comments: Photo shows very widespread distribution of smelter waste.

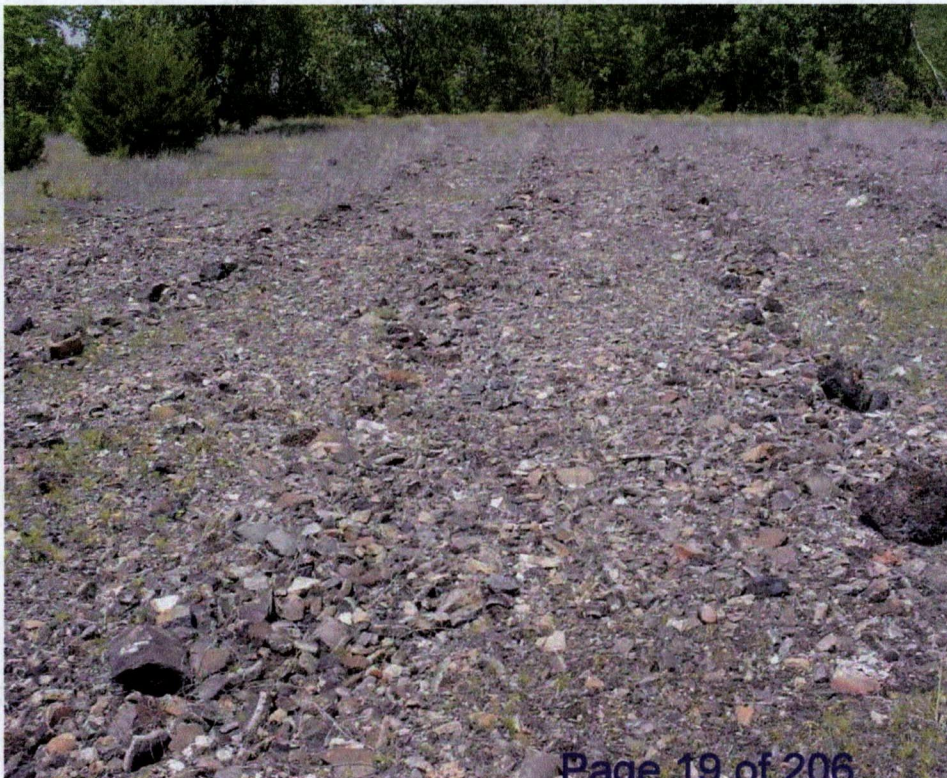
Photo 6
View: South
Date: 06/14/2012
Photo by: Randy Brown
Comments: Photo shows widespread extent of smelter waste towards the southern edge of the site.
